## Failure analysis of pulverizer pipe elbow in PLTU boiler

Hendri Chandra<sup>1</sup>, Rizki Zulkarnain<sup>2,\*</sup> and Muhammad Rafli Fazal<sup>3</sup>

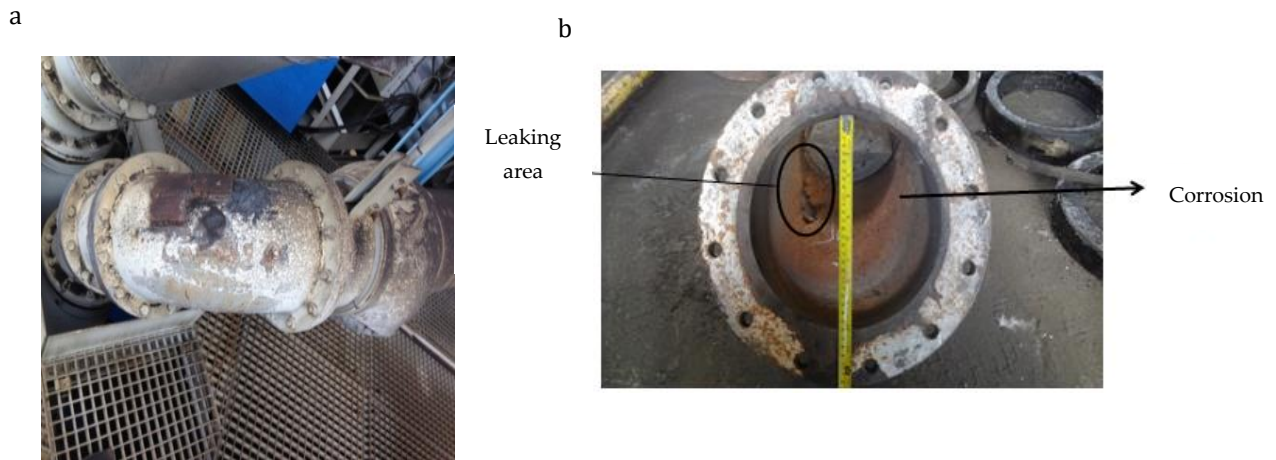
Before moving the specimen, it should be captured on camera or sketched (Visual observation). After the pipe has been taken out of the ditch, pictures should also be taken. In addition to the date and time the photo was taken, it is a good idea to label each image with the test section, failure number, and other information. The results of visual observations on the pulverized pipe that is being installed shows that on the surface of the

pipe there has been loss of metal which is indicated by a leak on the surface of the pipe so that a patch is made on the pipe as shown in the Figure 3 below.

Figure. 3. (a) The condition of the pulverized pipe in operation; (b) Observation of the pulverizer pipe elbow on the inside

From the results of observations focused on pulverized pipes in the field that are no longer used, it shows that in general these pipes have suffered wear damage due to abrasive powdered coal fluid flowing in the pipe due to the abrasive flow of powdered coal fluid flowing in the pipes and based on the chronology of the pulverized pipes, they have undergone pipe replacement (re-piping). and repairs by patching using silicon so that the pipe can still operate.

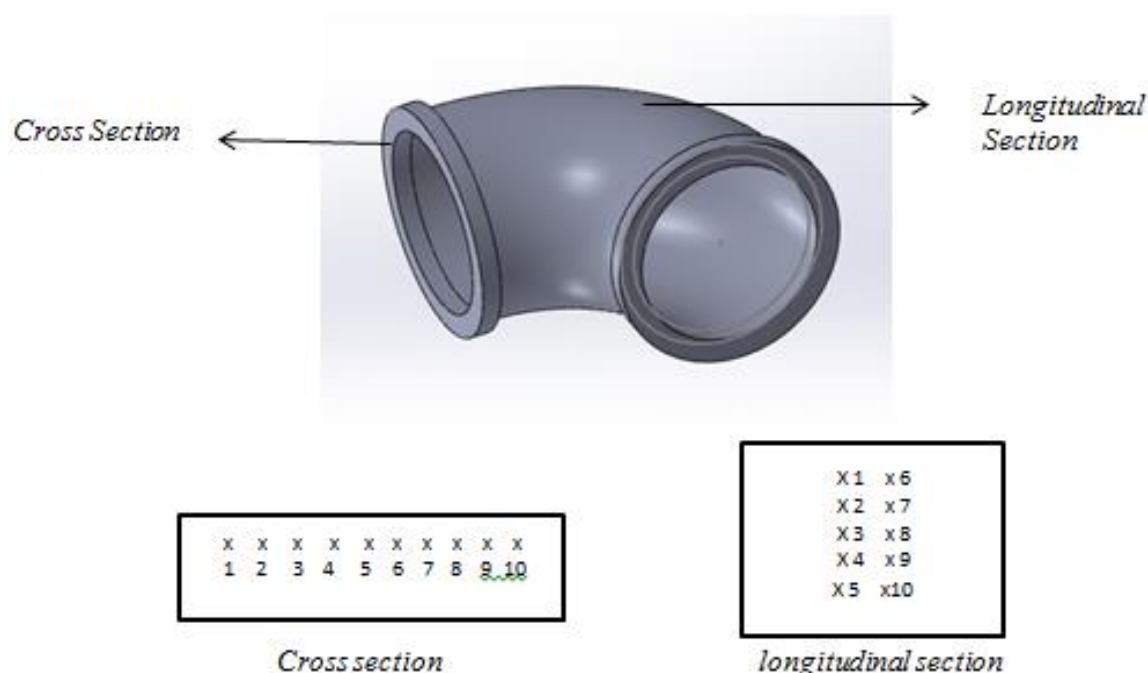
Figure. 4. Hardness testing sketch

The hardness test is carried out on cross sections and longitudinal sections or on the abrasive surfaces of the elbows and the elbow sample material, obtaining data for each part of the figure (Figure 4).

It can be seen from the table above that the hardness value in the sample has a nominal minimum hardness value of 155.01 HV in the cross section and 170.59 HV in the longitudinal section. If the hardness value of the elbow material is harder than the hardness value of the coal particles, then the elbow material will be more resistant to abrasiveness. While the hardness value of coal is 59 HGI, this shows that the elbow surface material is harder than the coal particles flowing in the pulverizer pipe.

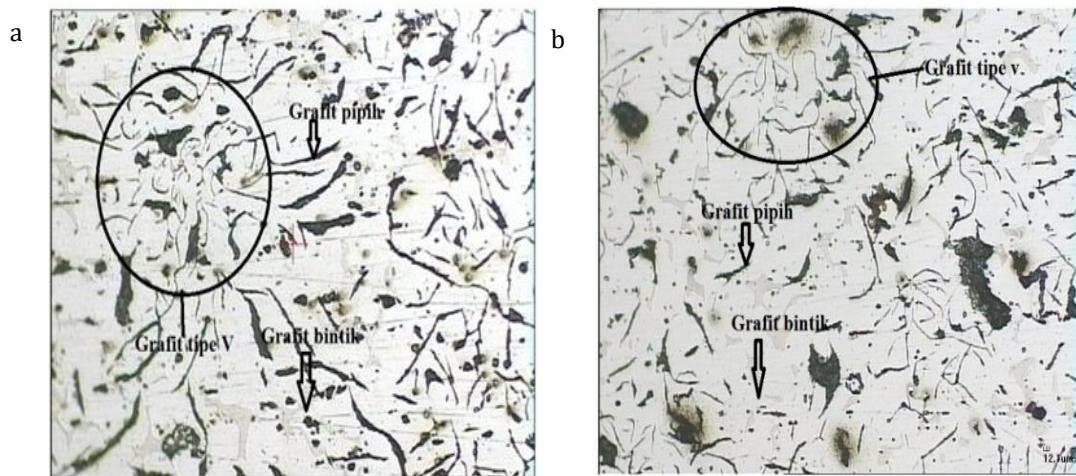
Figure 5. (a) Cross section before etching 100x magnification; (b) Longitudinal section before etching 100x magnification

The results of microstructural observations on elbow samples in the cross section and longitudinal section before etching showed that the gray cast iron was flake graphite type V (with star-like graphite). From the picture above it can be seen that the condition of the sample is not good, there are lots of nodules and corrosion which indicates that the elbow has many indications of defects caused by abrasives caused by coal particles flowing in the pipe, especially in the longitudinal section there is a lot of corrosion and nodules. so that the microstructural image of the sample is somewhat different from the microstructural image of gray cast iron in general. The microstructure was carried out at three points in each cross section and longitudinal section, from the figure above it shows that from microstructural observations before etching on the elbow samples which were directly affected by the abrasive the results showed that there were many defects in the samples.

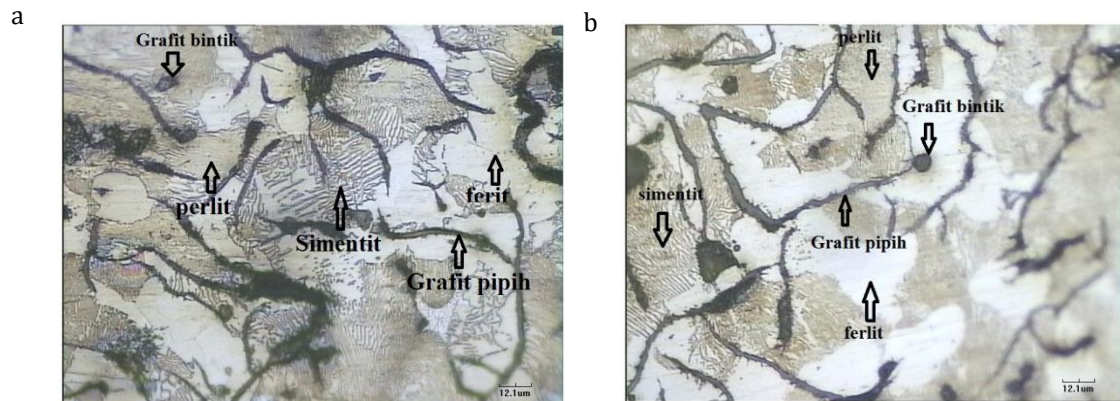
The results of observing the microstructure after etching show that the microstructure of the elbow material is ferrite (white), pearlite (black), cementite and graphite. Ferrite has clay properties, pearlite is ductile and has excellent wear resistance, so cast iron is a very suitable material for pipes. Cementite is very hard so that cementite deposition causes wear resistance. Graphite is a soft and brittle crystalline form of carbon. The state of the pieces of this graphite has a great influence on the mechanical properties of the casting, with graphite in the form of flakes causing stress concentrations at the edges (Figure 6).

Figure. 6. (a) Cross section after etching magnification 500x; (b) Longitudinal section after etching magnification 500x

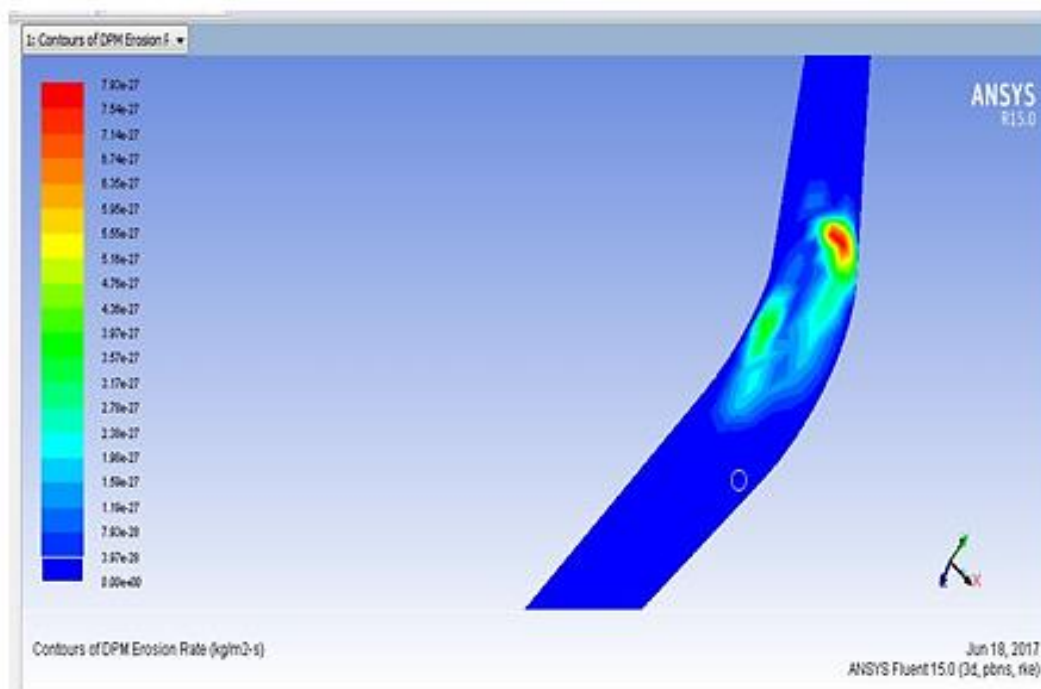
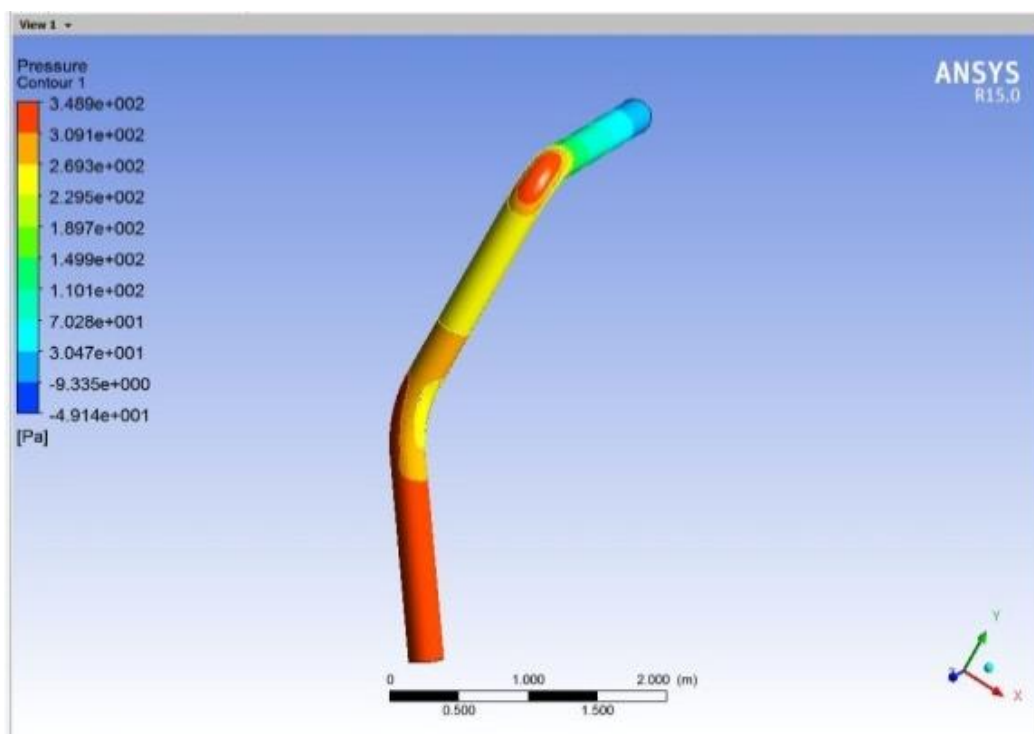
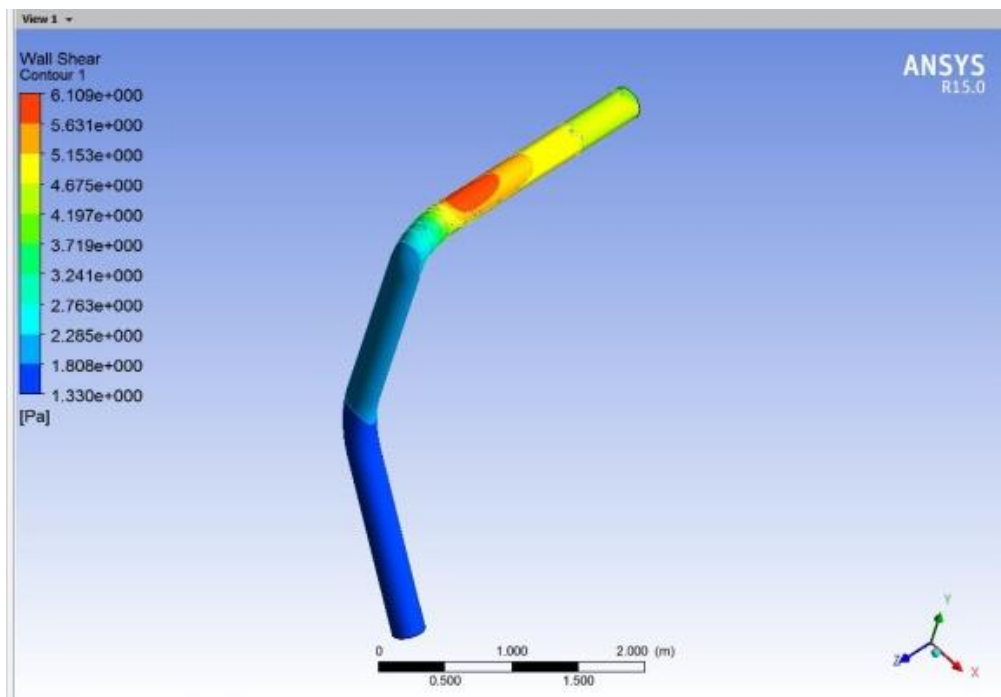
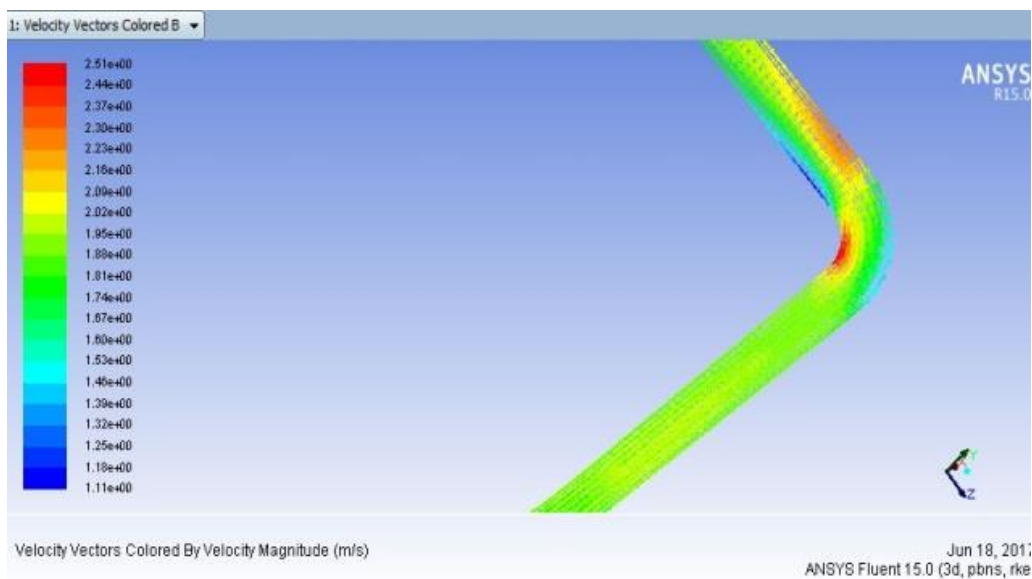
Figure. 7. ANSYS erosion corrosion modeling

Figure. 8. ANSYS pressure contour modeling results

Figure 9. Results of ANSYS shear stress contour modeling

Figure 10. ANSYS speed vector modeling results

The results of the ANSYS simulation in the figure above show that the main factor causing the leaking of the pulverizer pipe elbow is erosion corrosion as shown in the figure, in the leaking area the concentration of corrosion is higher than in other areas, which is indicated by the presence of a red color in the area. Areas affected by erosion corrosion are marked in light blue, green, yellow and red, the magnitude of the maximum erosion corrosion value that occurs in the pulverizer pipe elbow with an erosion rate of  $7,93 \times 10^{-27}$  kg/m<sup>2</sup>s.

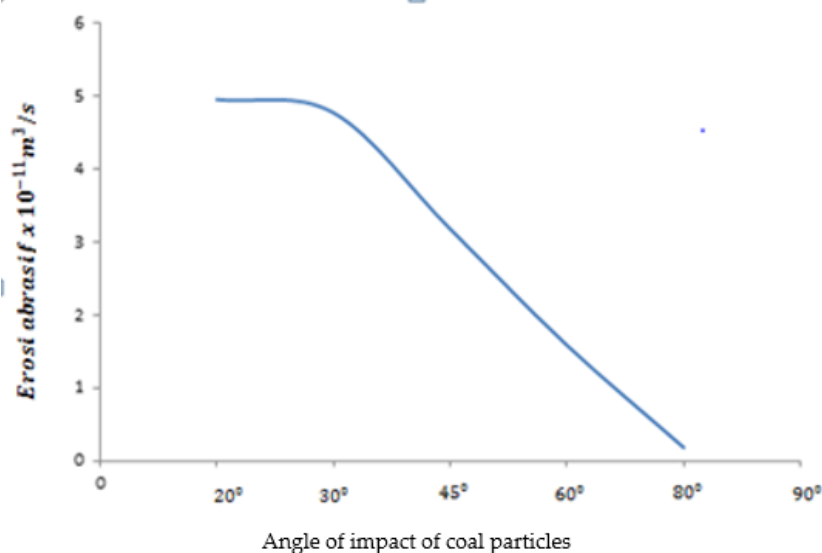
Figure. 10. Graph of erosion rate relationship with impact angle

From the calculation above it can be concluded that the greatest erosion rate occurs at an angle of 20° with a value of  $4,9548 \times 10^{-11} \text{ m}^3/\text{s}$ , the smaller the angle of impact of coal particles hitting the pulverizer pipe elbow material, the greater the erosion rate that occurs in the pulverizer pipe elbow material. The angle of impact of coal particles on the pulverizer pipe elbow affects the rate of erosion which causes damage to the material.
